Manhole Inspection Summary

Manhole # S55C__030MH

Location Address: **3526 e baltimore st**

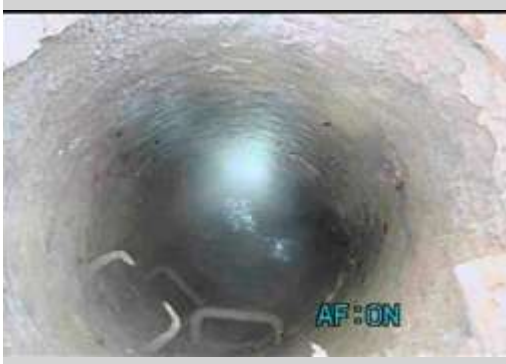
Top View

Steam at bottom of hole cant get bertter top view

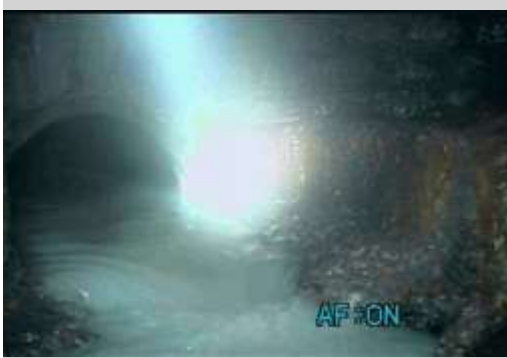
misc

channel debris

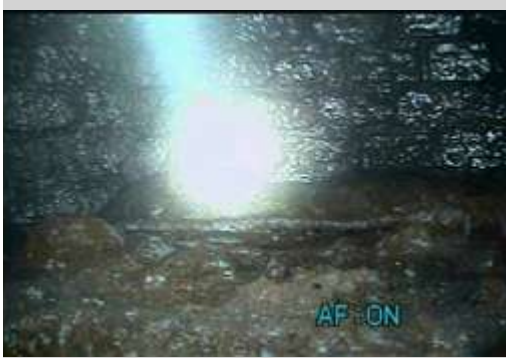
Defect 3

Infiltration: ☐ None ☐ Joint ☐ Cracks ☐ Mortar ☐ Roots ☒ **Wall**

Barrel infiltration

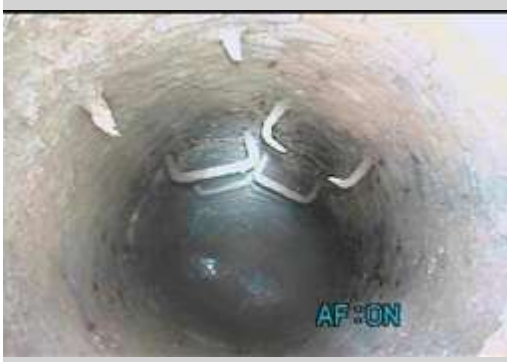
Defect 2

Steps Count: **7** Missing: **2** ☒ **Corroded**

missing & corroded steps

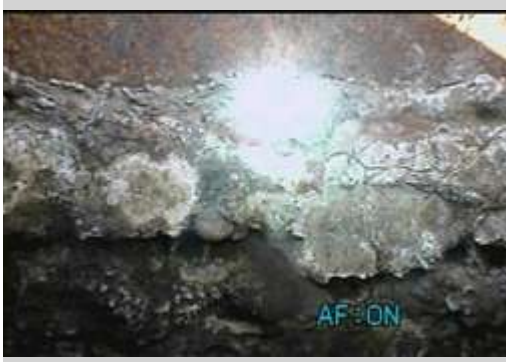
Defect 1

Condition: ☐ Sound ☐ Cracked ☐ Root Intrusion ☐ Loose Brick ☒ **Deteriorated**

chimney cond_deteriorated frame adj

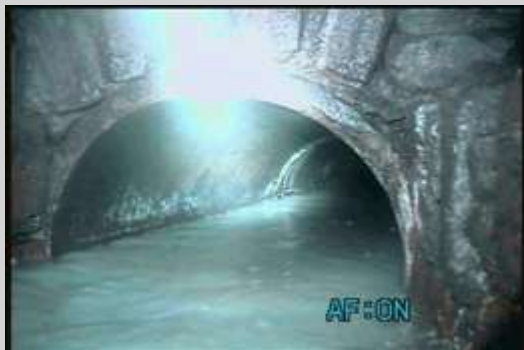
12 O'Clock Outflow

12 in. Circular Gravity Sewer
Pipe Out @ 12 O'Clock

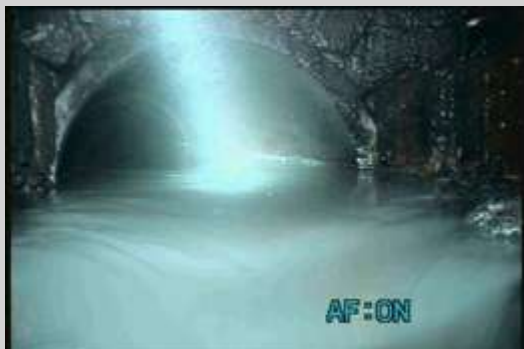
3 O'Clock Inflow

12 in. Circular Gravity Sewer
Pipe In @ 3 O'Clock
